Enhanced Hydrology in Texas Lidar Critical to Risk Mapping

In 2017 the U.S. Geological Survey selected the Merrick-Surdex Joint Venture to collect and process lidar data of approximately 17,950 square miles in southwest Texas through

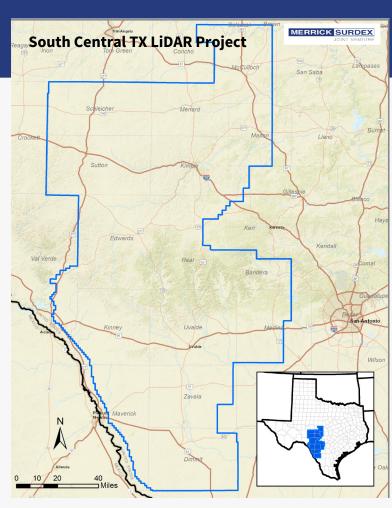
2018 southwest Texas lidar project area

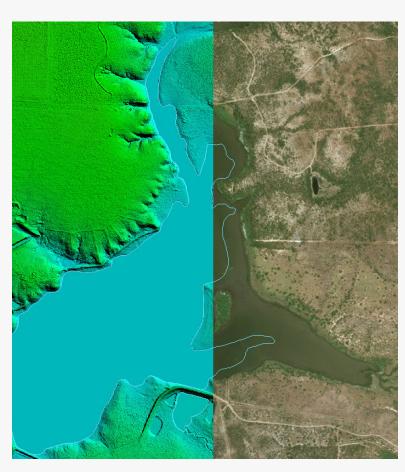
Hydrological feature from project lidar data (left) compared to non-drought imagery (right)

The Joint Venture's hydrographic feature collection effort was designed to ensure map accuracy and exceed the USGS project specifications so that hydrological events could be monitored with confidence. At the time of this project, version 1.3 of the USGS Lidar Base Specification was the most current version. According to this set of specifications, the minimum width for collection of inland streams and rivers is 100 feet; however, due to the low water levels there were multiple instances where these features were as narrow as 10-15 feet, meaning they ordinarily would not have been collected. In several cases, widths varied considerably along the same stream, and if only the portions of rivers/streams that were greater than 100 feet been collected, it would have resulted in disconnected networks of drainage.

Additionally, several lakes/ponds would have been omitted for not meeting the minimum two-acre size criteria. These conflicts of elevation in the hydro-flattened Digital Elevation Models (DEMs) would have limited the utility of the data to all agencies. The selected process ensured hydrological events could be monitored with confidence and guaranteed proper map accuracy. This enhanced data can be used by many agencies such as the U.S. Army Corps of Engineers (USACE), TWDB and Natural Resources Conservation Service (NRCS) to verify information required for river level management.
